Odor Investigation

**Abbot Elementary School
25 Depot Street
Westford, Massachusetts**

Prepared by:
Massachusetts Department of Public Health
Bureau of Environmental Health
Indoor Air Quality Program
October 2019

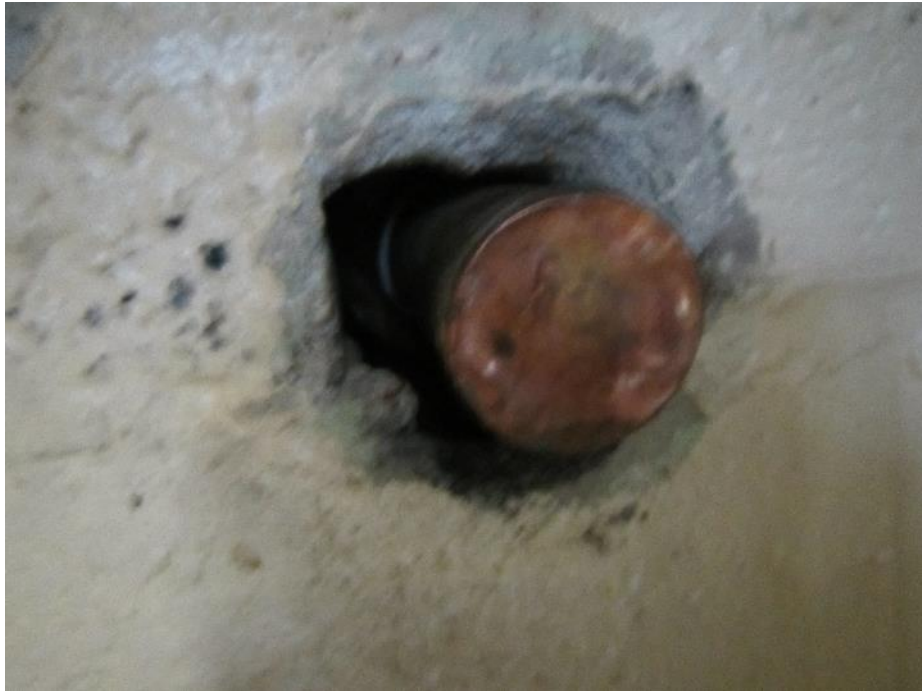
Picture 1

Slight sewer odors were noted in the instructional suite but were strongest in the former restroom. The plumbing fixtures had been abandoned and capped years prior to this visit. Occupants noted that sewer-like odors were detected intermittently for approximately one and a half years. BEH/IAQ staff noted that the thin-walled copper fitting used to cap the old sink drain appeared damaged in some areas (Picture 1). The plastic plug used to cap the abandoned toilet drain line was in place but did not appear to have any locking mechanism to properly secure the plug to the toilet drain flange. In addition, no sealant (e.g., silicone) appeared to be used around the plug to ensure an airtight seal within the old toilet drain line (Picture 2). Further, BEH/IAQ staff noted several gaps in the concrete block wall around the water/drain lines (Picture 3).

It is likely that sewer odors are being drawn from openings around the old caps of the abandoned drain lines. Other odors may enter the instructional suite through breaches leading to the wall cavity. With exhaust only ventilation, the building is *depressurized* which exacerbates these conditions. This was evident by the feeling of strong airflow coming from the gaps around the plumbing lines in the wall.

Abandoned sink drain showing damaged, thin-walled cap

1. Work with a plumber to properly reseal the abandoned toilet drain and sink drain lines. Use best practices to obtain an airtight seal and secure connection to the drain lines.
2. Seal all holes/breaches around the plumbing lines in the wall and floor of the former bathroom.
3. Seal all holes/breaches in the ceiling tiles and walls of the instructional suite which may serve as pathways.
4. Ensure local exhaust vents are operable in active restrooms but consider consulting with an HVAC contractor to reduce the strong building-wide depressurization until supply air ventilation is introduced to balance/slightly pressurize the building.
5. Continue to use openable windows to supplement fresh air during temperate weather. Ensure all windows are tightly closed at the end of the day.

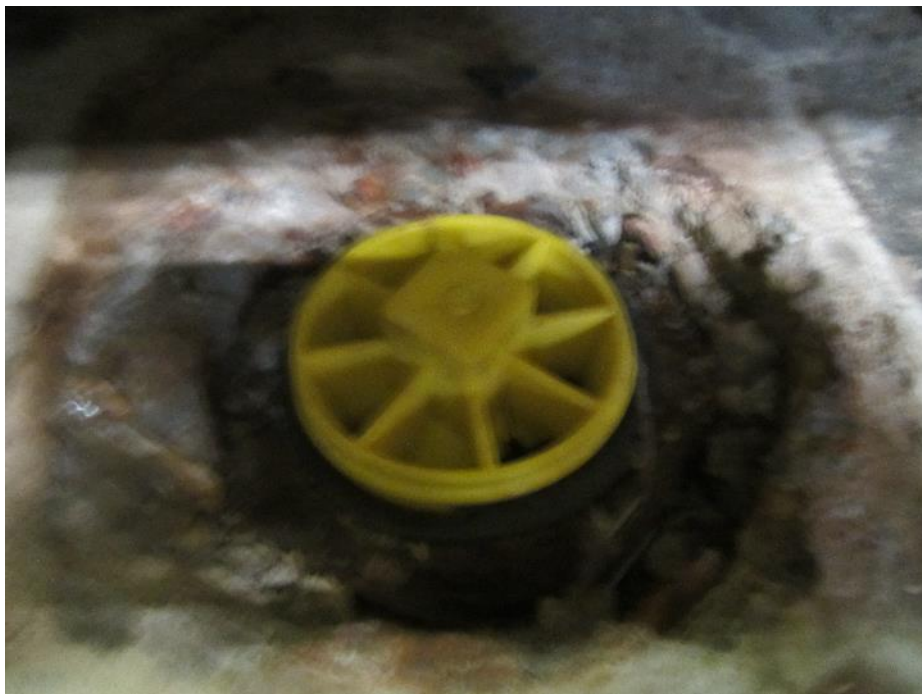
Picture 2

Plastic plug blocking abandoned toilet drain; note apparent lack of sealant and locking mechanism

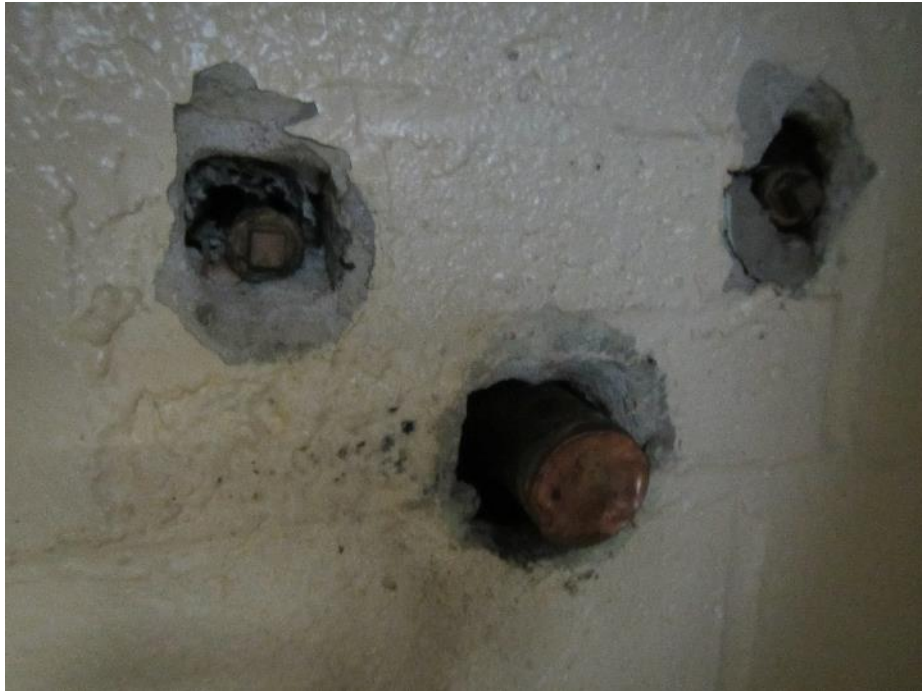
Picture 3

Note gaps/breaches in wall around utilities leading to unconditioned wall cavity

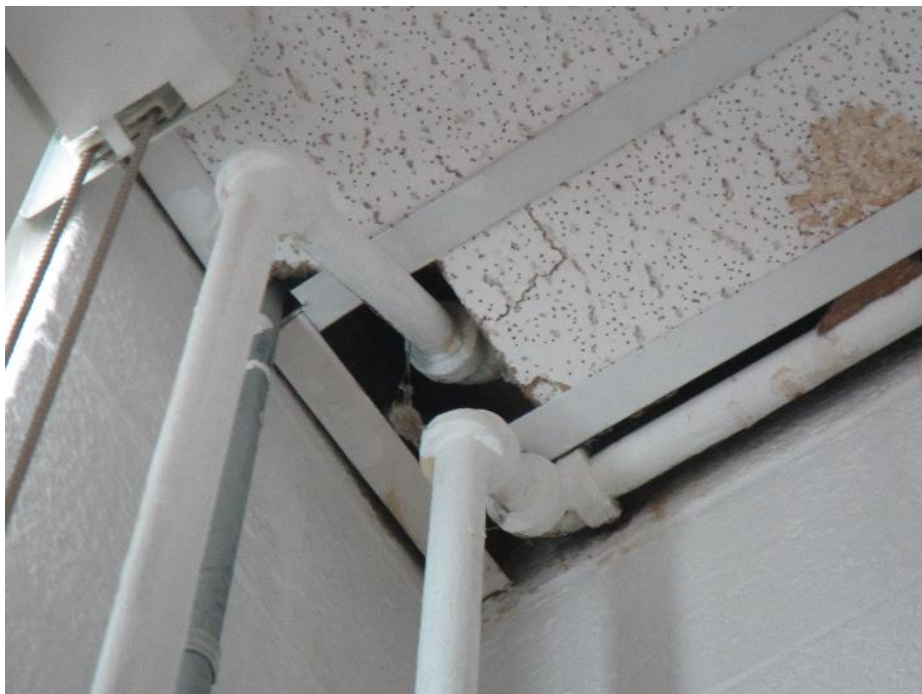
Picture 4

Additional open holes/breaches were also observed in the ceiling tile system and in the wall of the instructional area (Pictures 4 and 5). These breaches are not likely to be the source of the reported odors but rather could serve as pathways for odors to travel to other areas of the building.

Breaches in the ceiling tile around utilities serve as pathways

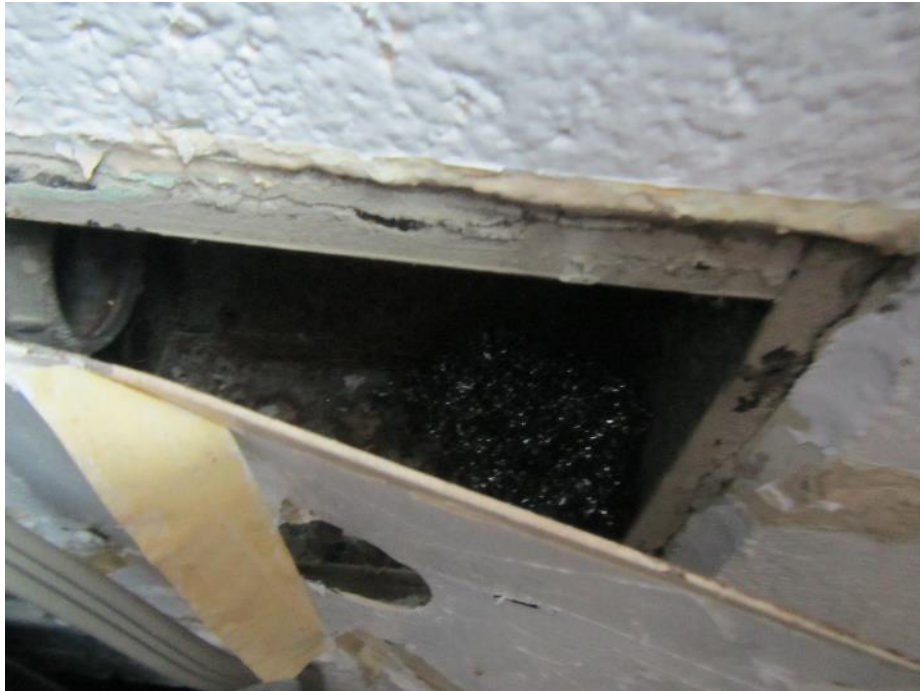
Picture 5

Abandoned electrical box/conduit in wall may serve as pathway
